FLIGHT TESTS OF VARIOUS TAIL MODIFICATIONS

ON THE BREWSTER XSBA-1 AIRPLANE

I - MEASUREMENTS OF FLYING QUALITIES

WITH ORIGINAL TAIL SURFACES

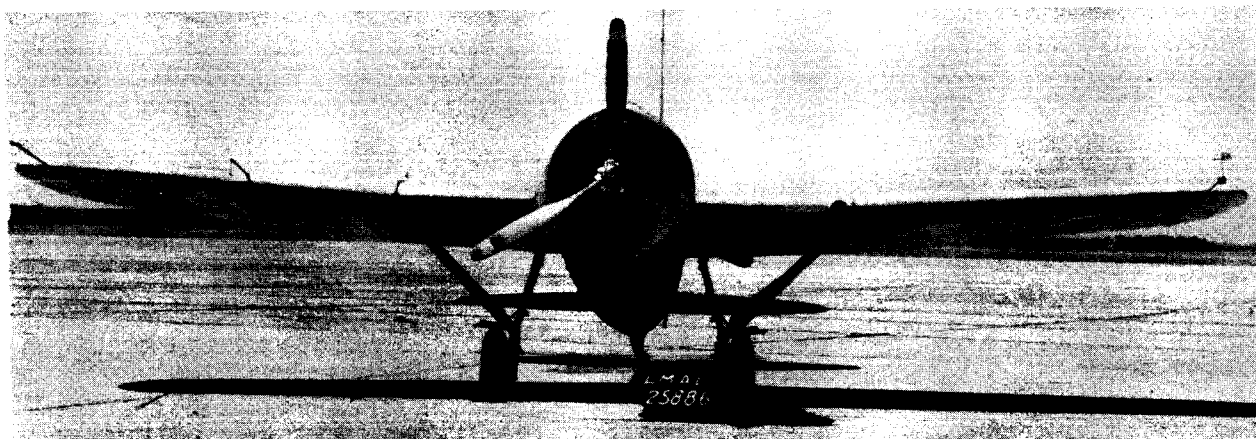
Figure 1.- Front view of Brewster XSBA-1 airplane.

The XSBA-1 airplane is a two-place, single-engine, mid-wing, cantilever monoplane with retractable landing gear. For the investigations described in this report, the cut-outs in the flap were sealed to give a conventional partial-span split flap. (See figs. 1 to 4.) The general specifications of the airplane follow:

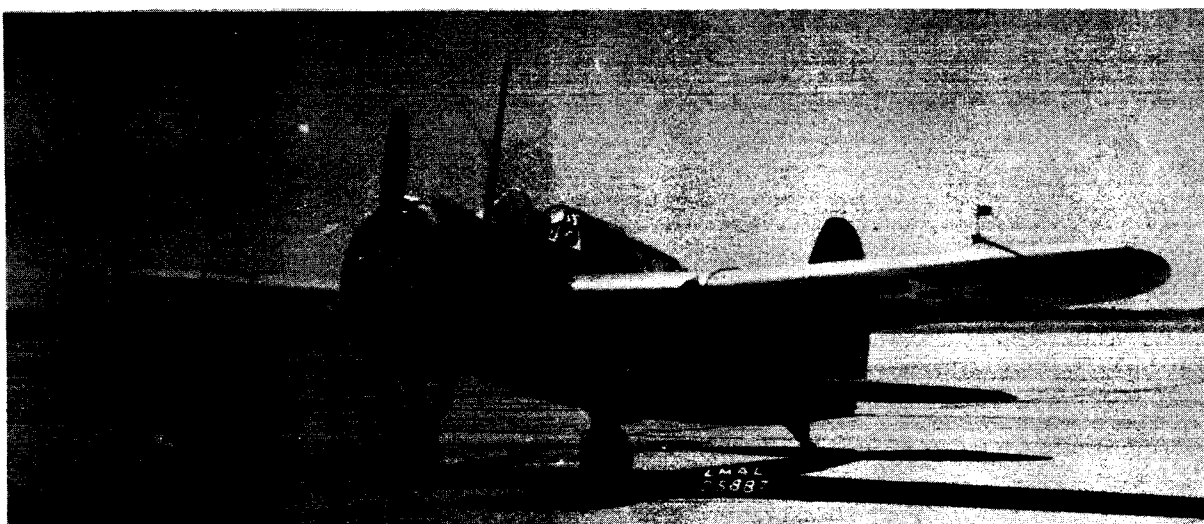
Figure 2.- Three-quarter front view of Brewster XSBA-1 airplane.

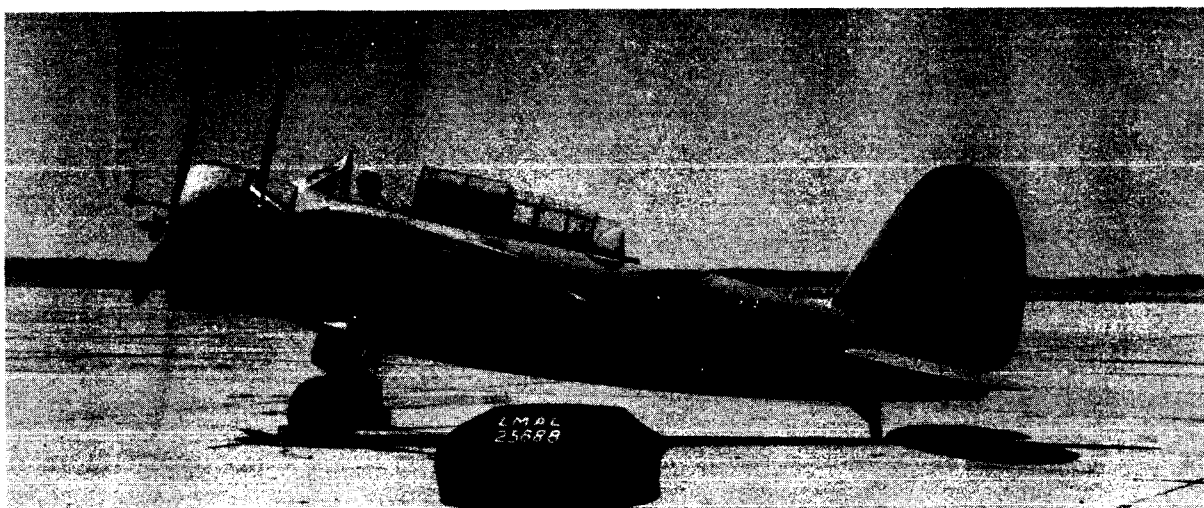
Figure 3.- Side-view of Brewster XSBA-1 airplane.

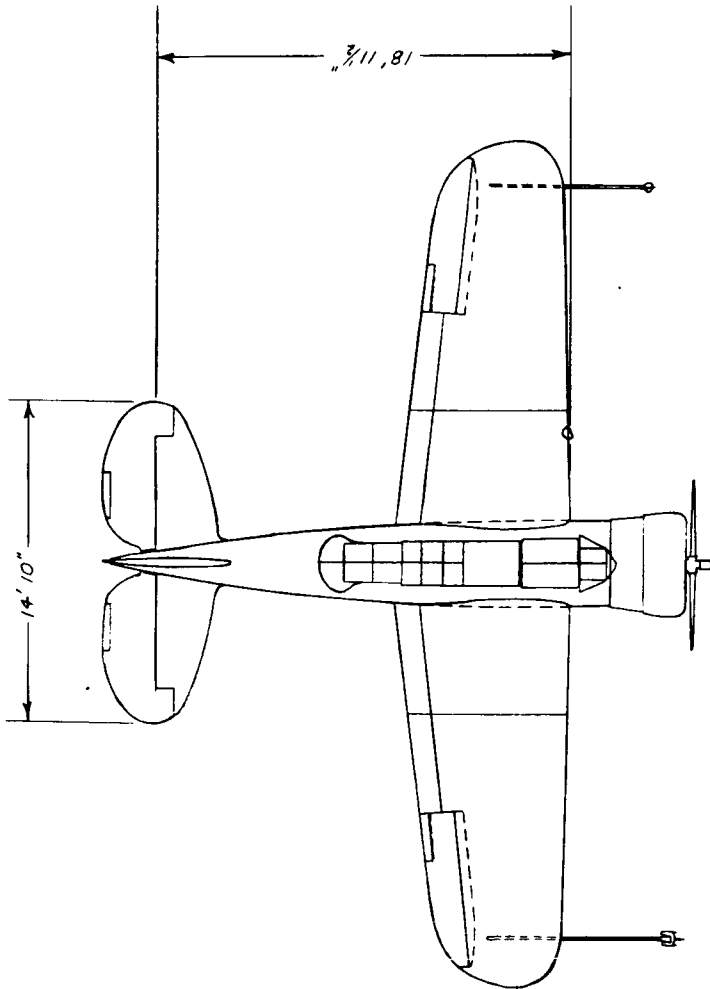
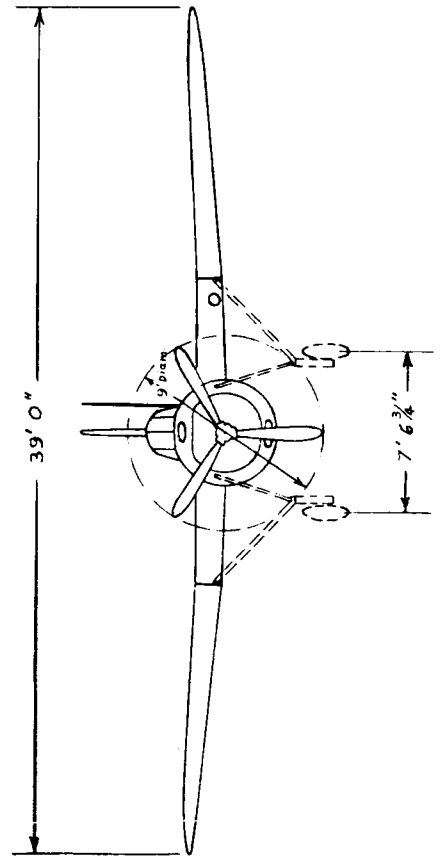
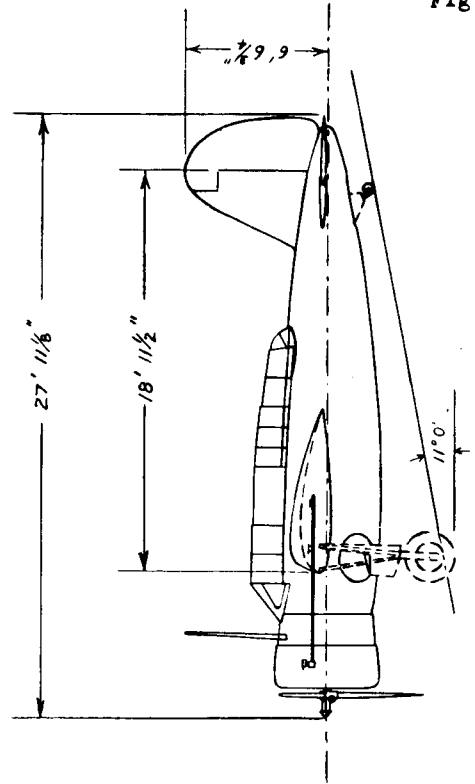
Fig. 4
Figure 4. - Three-view drawing of the Brewster XSBA-1 airplane.

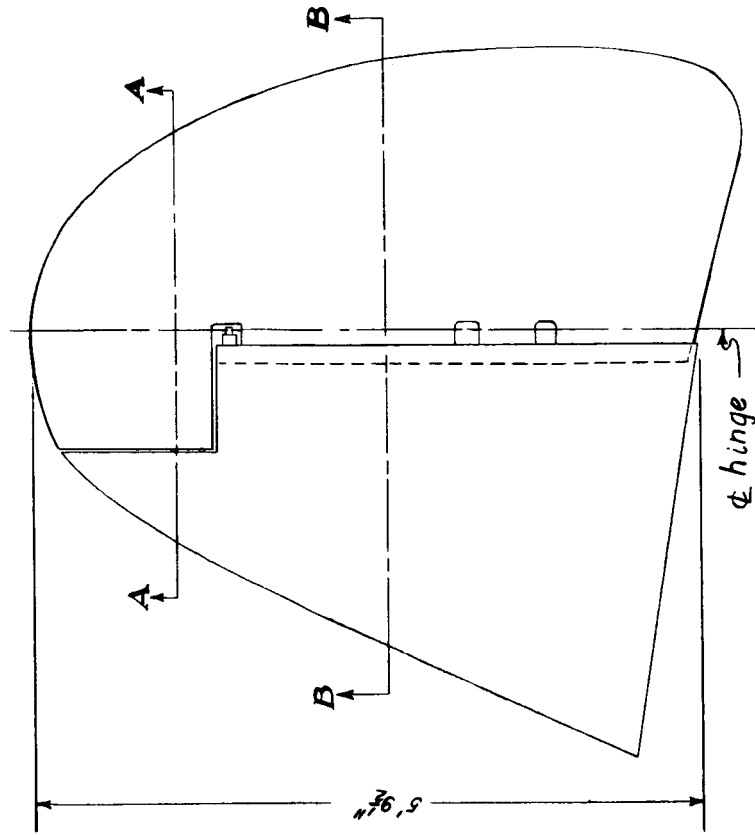
Figure 6. - Original vertical tail surface of the Brewster XSBA-1 airplane.

The original horizontal and vertical tail surfaces are shown in figures 5 and 6.

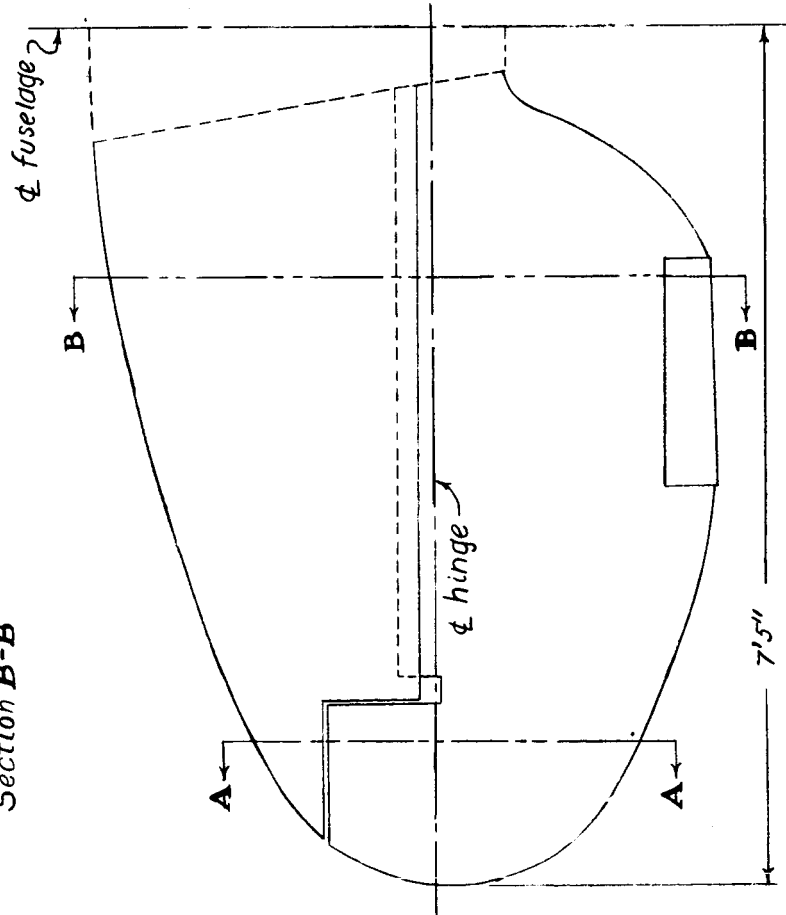
Figure 5. - Original horizontal tail surfaces of Brewster XSBA-1 airplane.

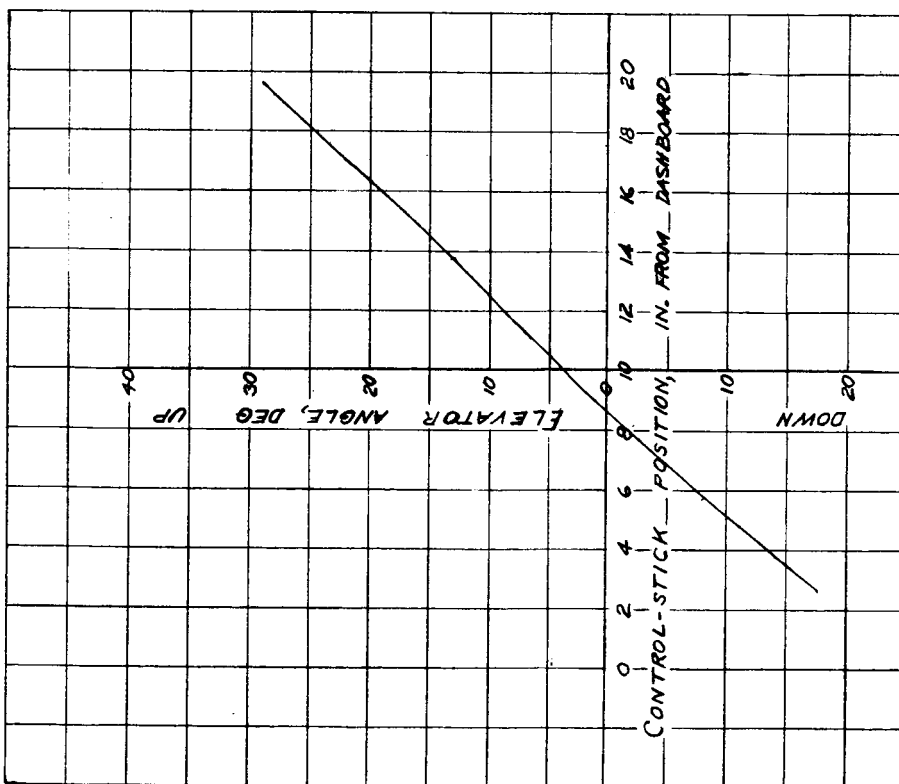
Figure 7. - Variation of elevator angle with position of the top of the control stick in front cockpit, Brewster XSBA-1 airplane.

The relation between the control-stick position and the elevator and aileron angles is shown in figures 7 and 8.

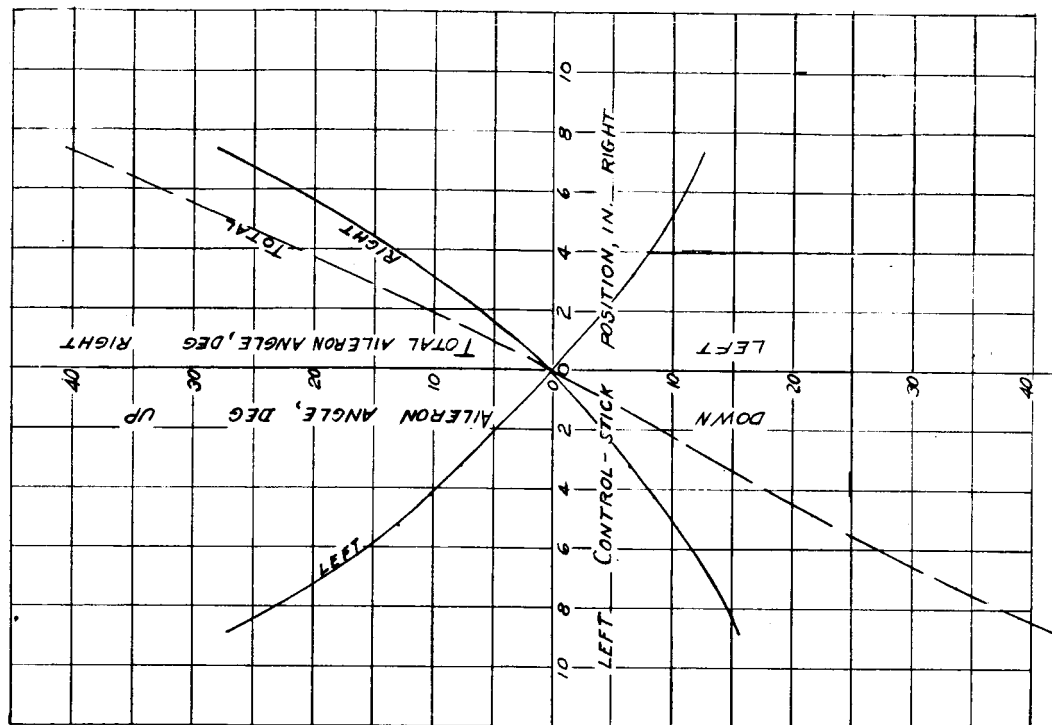
Figure 8. - Variation of angles of left and right ailerons and total aileron deflection with position of top of control stick, Brewster XSBA-1 airplane.

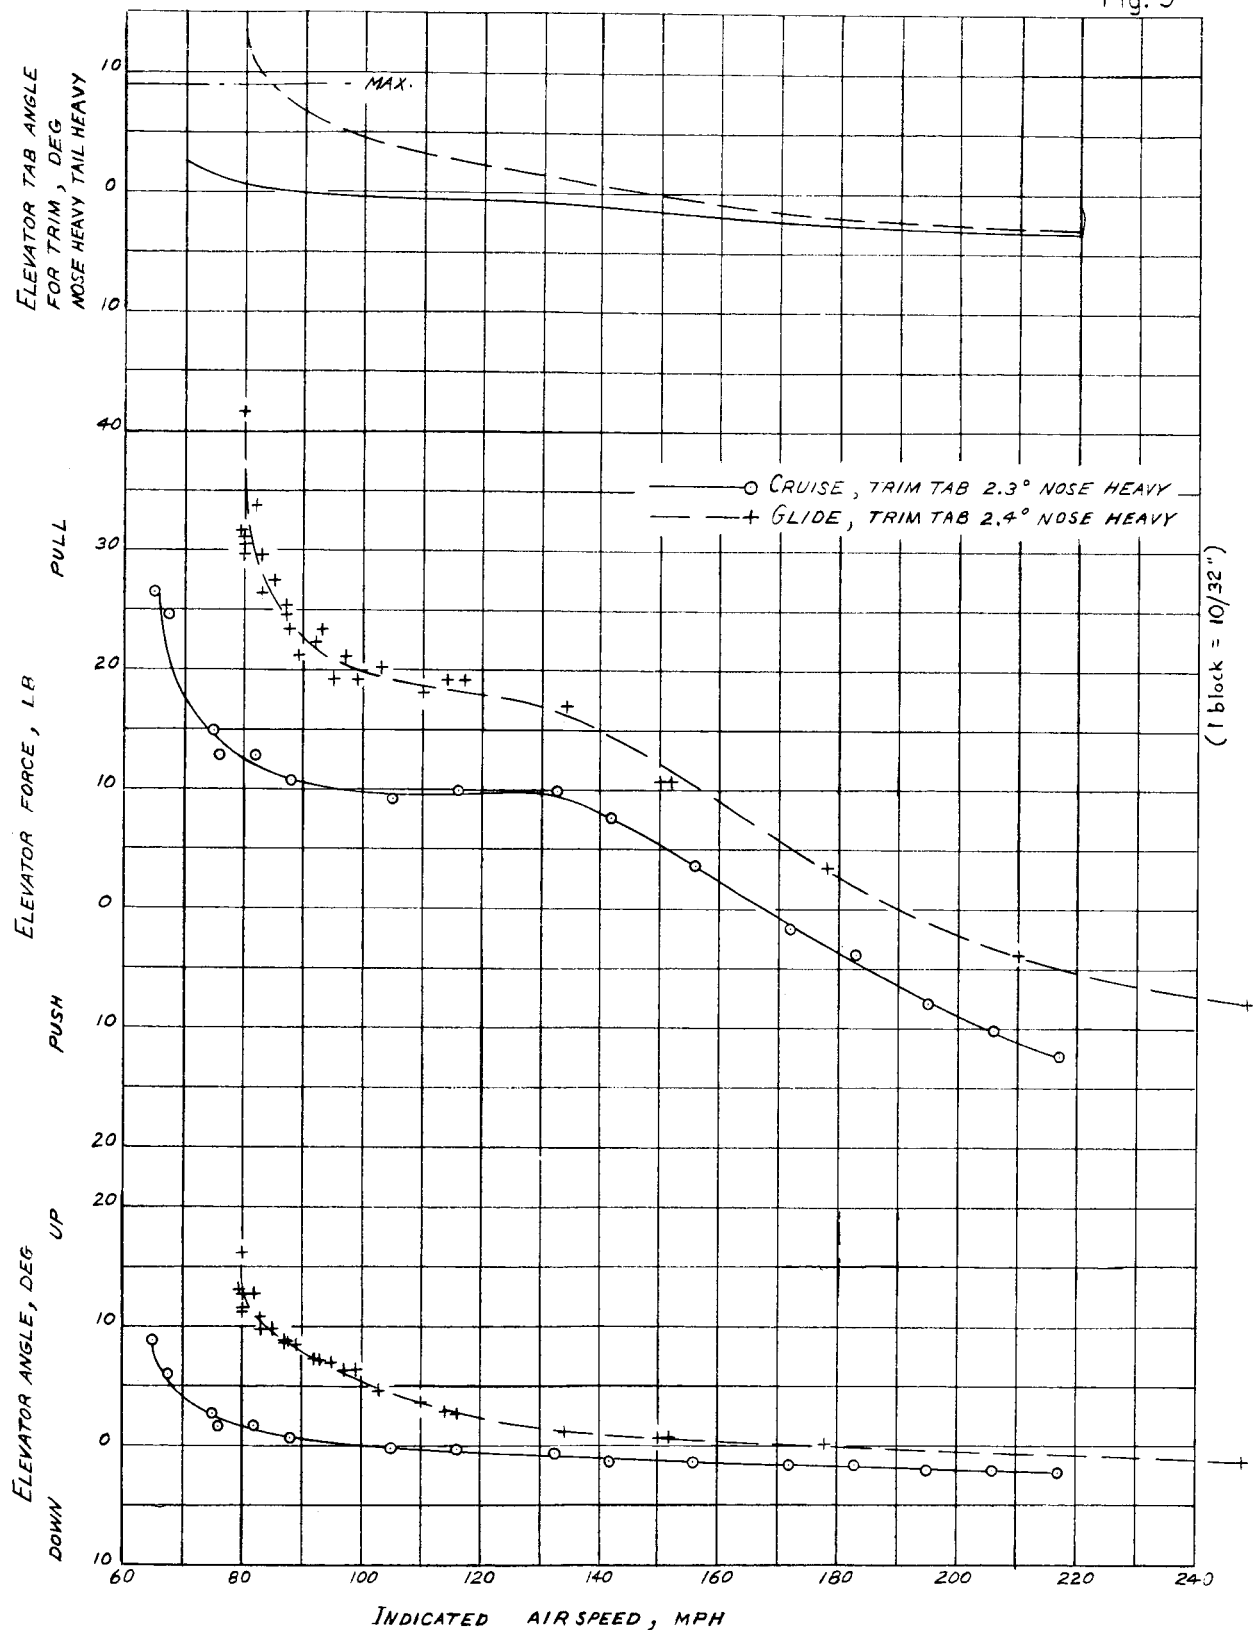
Fig. 9

Figure 9. - Variation of elevator angle, elevator force, and elevator tab angle required for trim with indicated airspeed in the gliding and cruising conditions; Brewster XSBA-1 airplane.

(1) In all the flight conditions tested, stick-fixed static stability existed, as shown by the negative slopes of the curves of elevator angle against airspeed (figs. 9 to 12). The stability was greatest in the landing condition (flaps and landing gear down, power off). It was also relatively large in the gliding condition (flaps and landing gear up, power off). The large increase in up elevator angle at low speeds in the gliding condition was believed to be caused by separation of the flow at the wing root as the stall was approached. The static stability possessed by this airplane in the flaps-down, power-on conditions of flight was unusually large, inasmuch as static instability is often encountered in these conditions.

The stick force per degree trimming-tab change as a function of indicated airspeed in various flight conditions is shown in figure 20. The trimming-tab setting required to trim at zero stick force in these conditions is plotted in figures 9 to 11. The trimming tabs were sufficiently powerful to

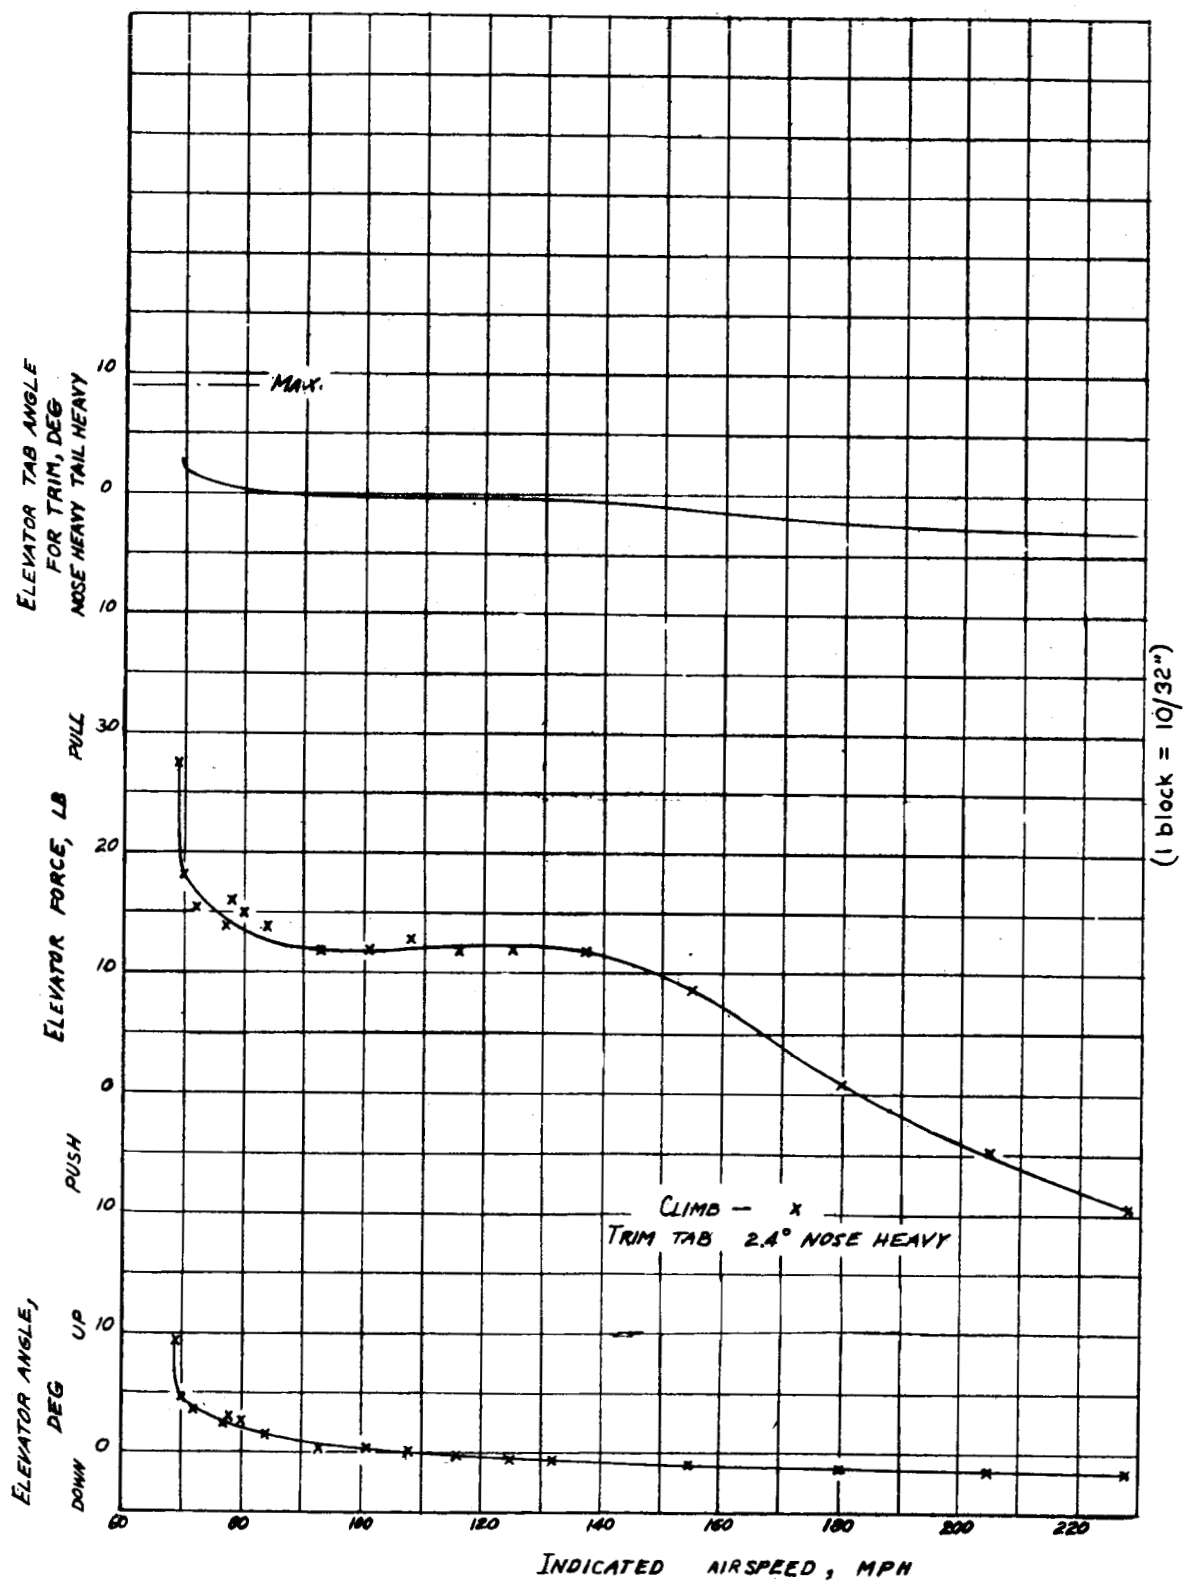
Figure 10. - Variation of elevator angle, elevator force, and elevator tab angle required for trim with indicated airspeed in the climbing condition; Brewster XSBA-1 airplane.

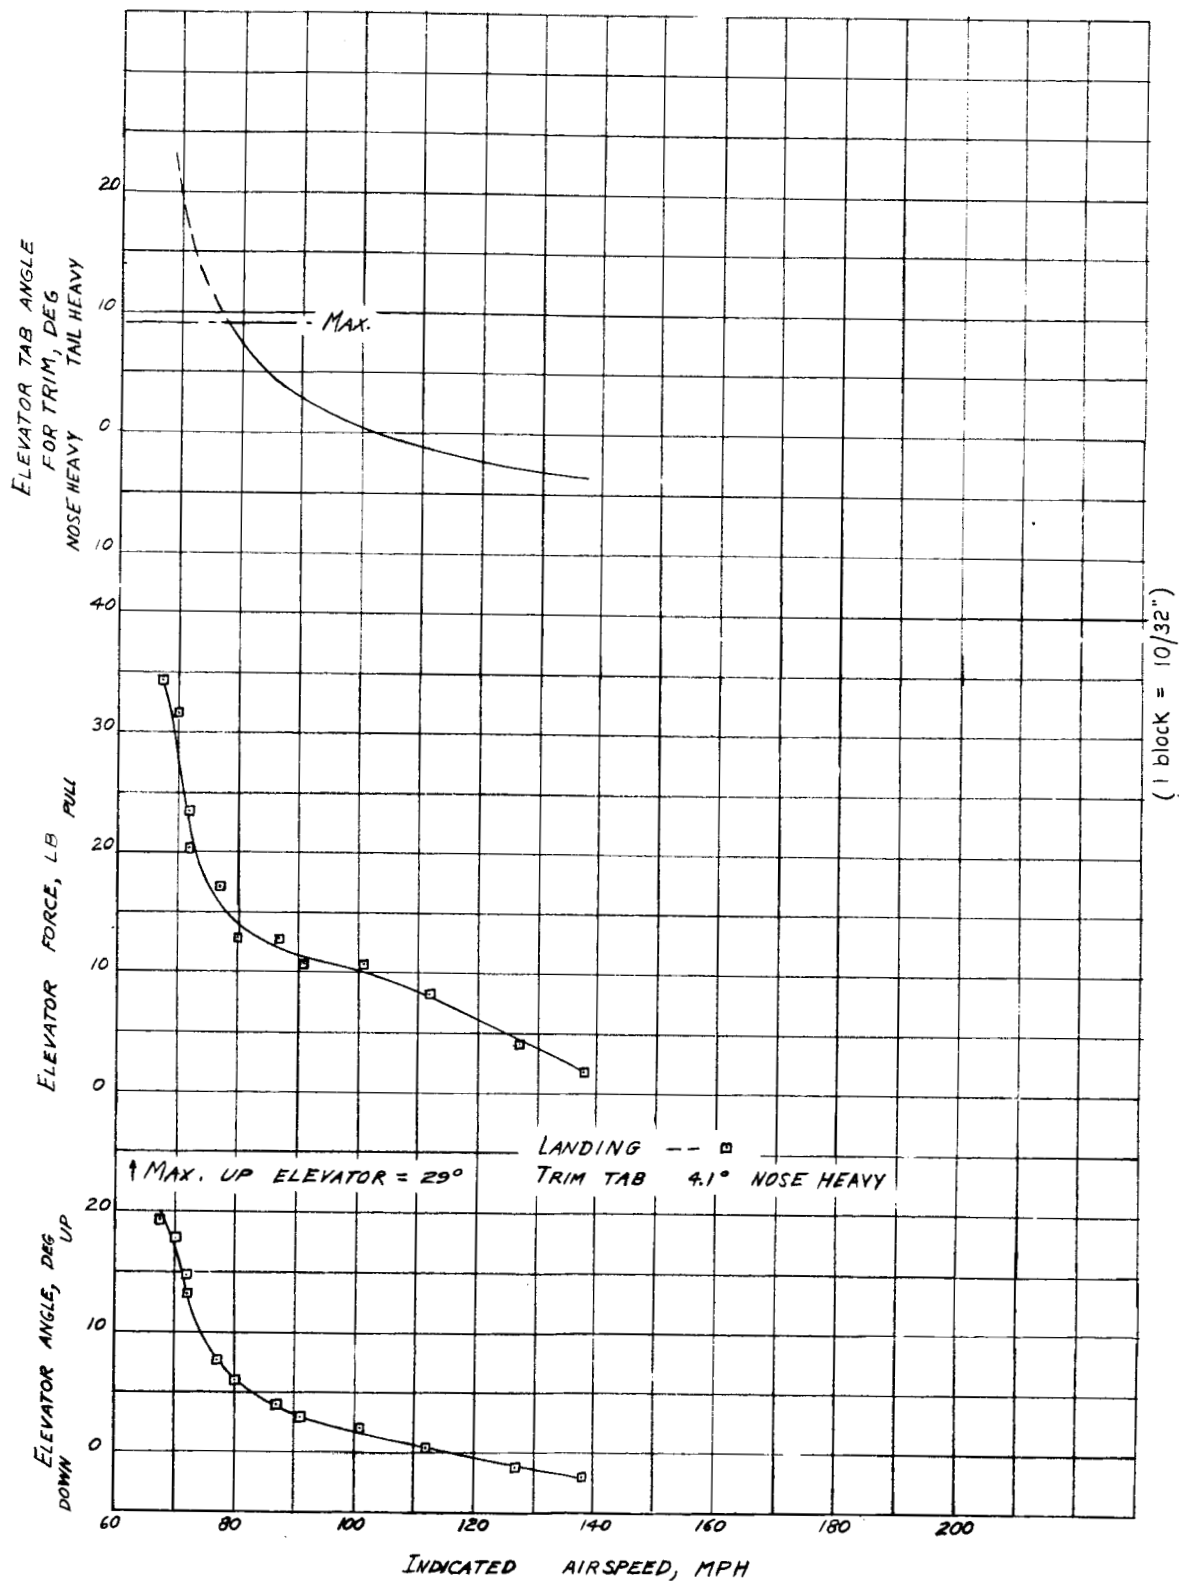
Figure 11. - Variation of elevator angle, elevator force, and elevator tab angle required for trim with indicated airspeed in the landing condition; Brewster XSBA-1 airplane.

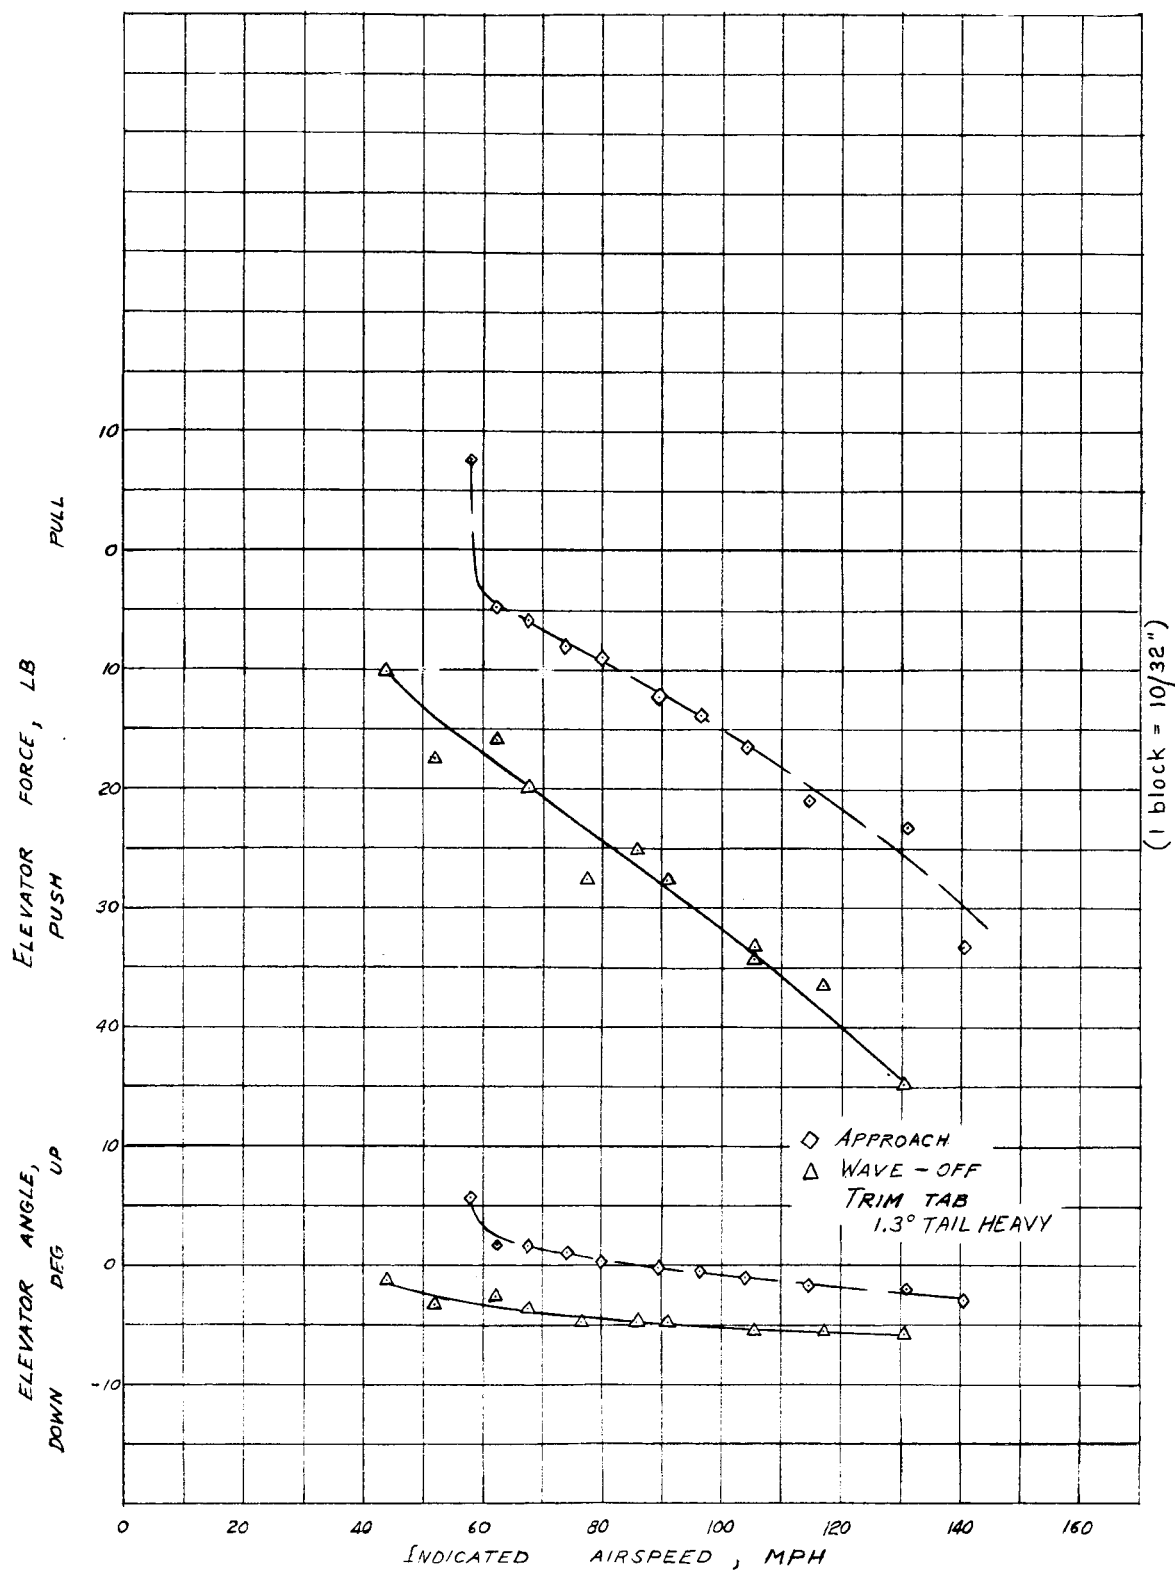
Figure 12. - Variation of elevator angle and elevator force with indicated airspeed in the approach and wave-off conditions; Brewster XSBA-1 airplane.

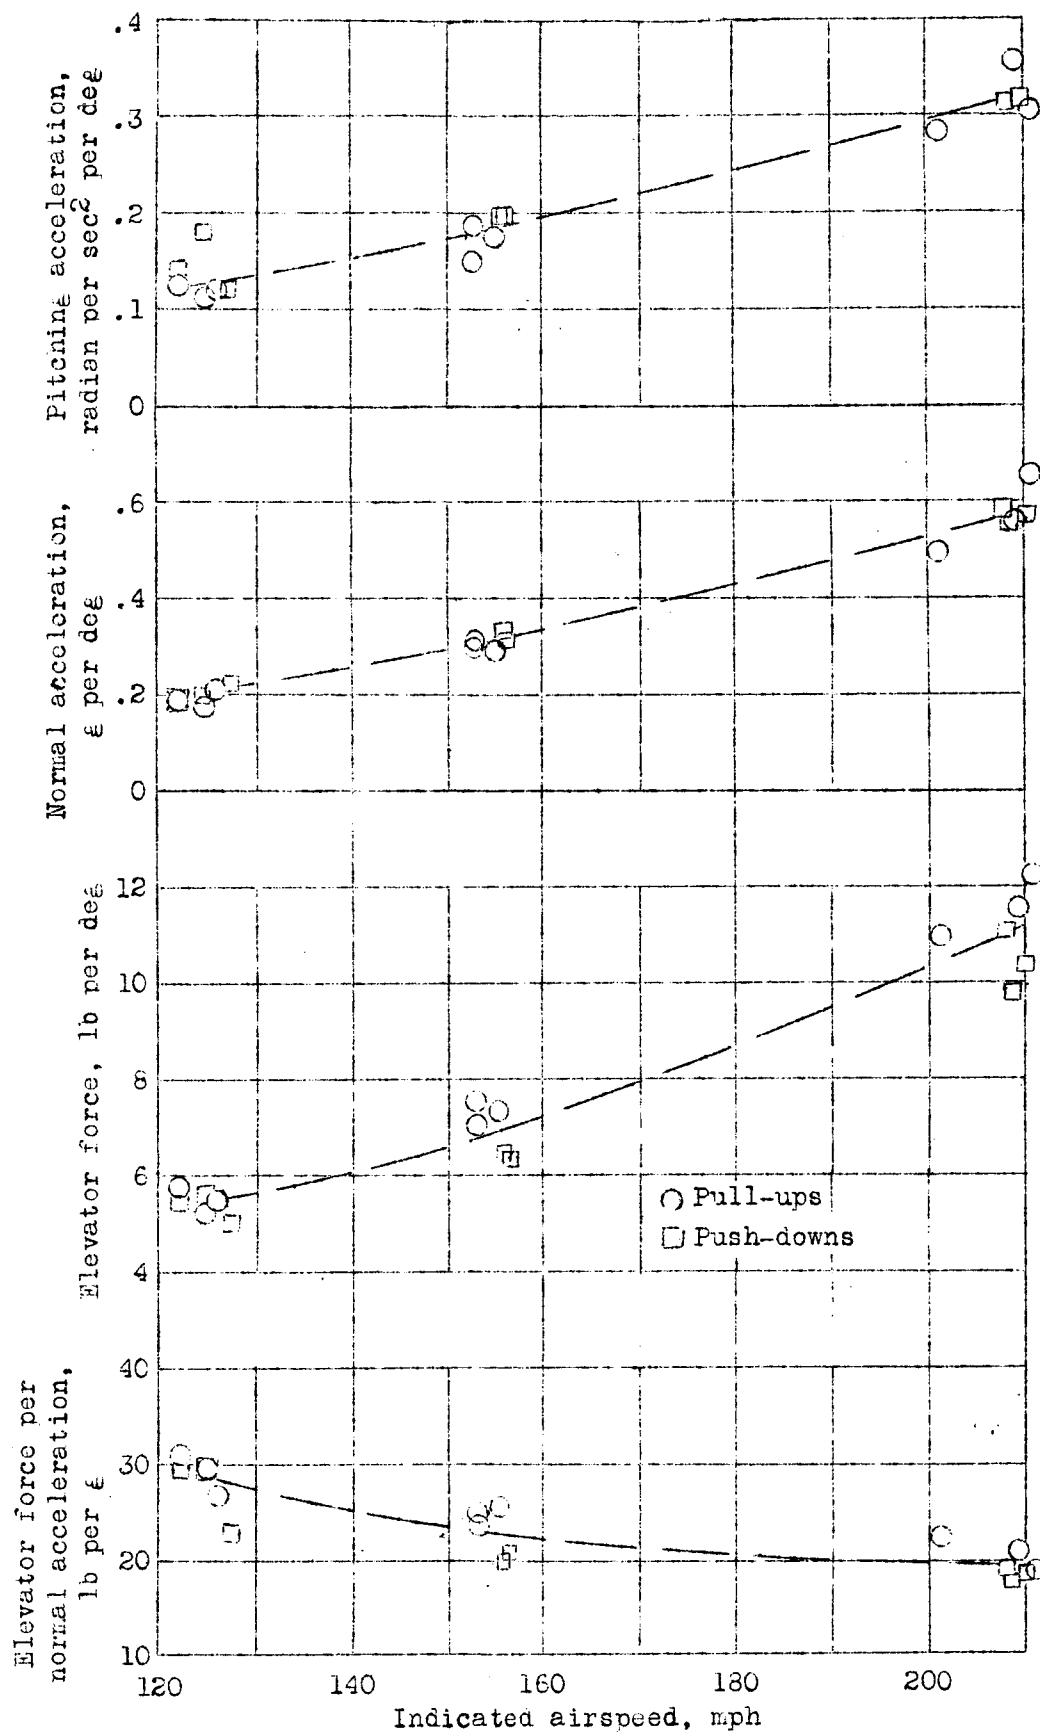
Figure 13.- Elevator control characteristics as measured in pull-ups and push-downs from level flight (flaps up, gear up). Brewster XSBA-1 airplane.

Characteristics of the elevator control in accelerated flight. - The characteristics of the elevator control in accelerated flight were determined from measurements taken in abrupt pull-ups and push-downs from level flight and in rapid 180° turns. The results of the pull-ups and push-downs are presented in figure 13. Time histories of representative turns are presented in figures 14 to 17. The results of the tests pertaining to the elevator control may be summarized as follows:

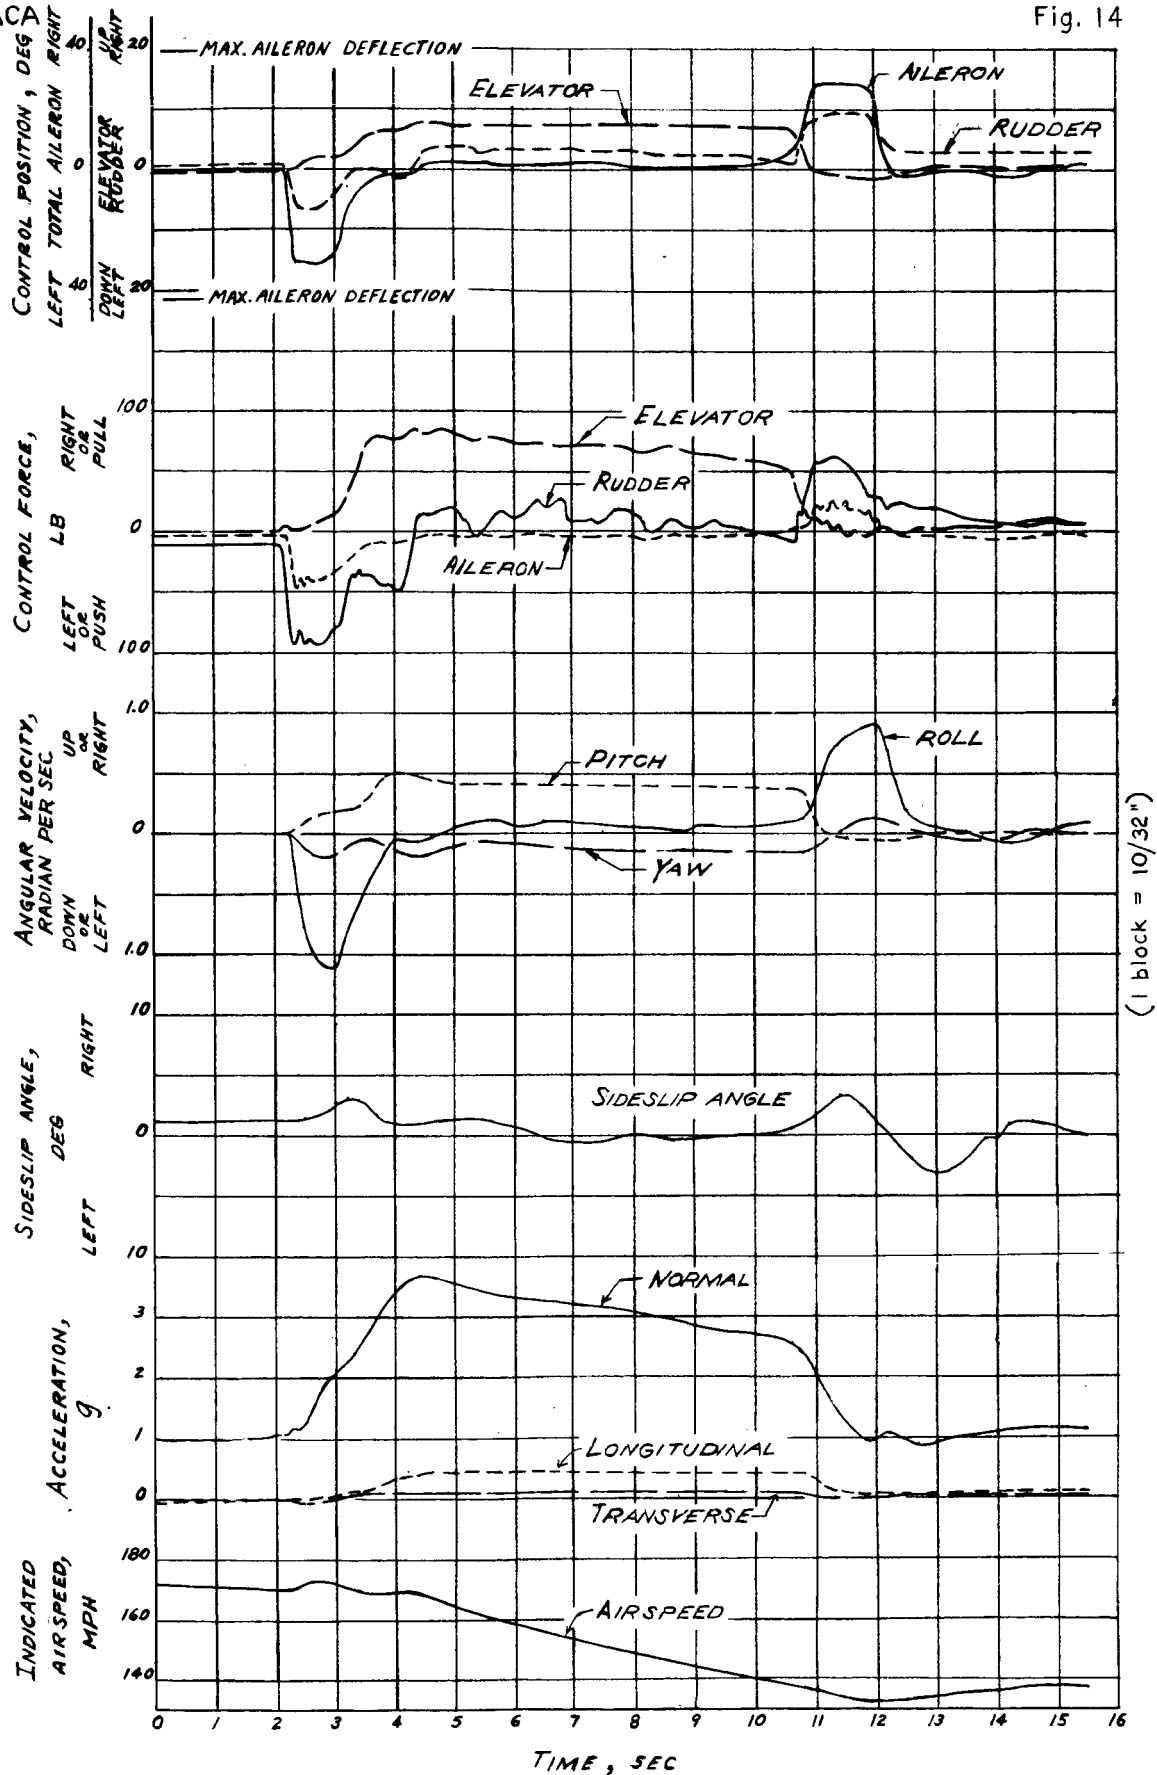
Fig. 14

Figure 14. - Time history of a rapid 180° turn to the left started at 172 miles per hour. Note large elevator force. Brewster XSBA-1 airplane, flaps up, gear up, 18 inches Hg manifold pressure, 1800 rpm.

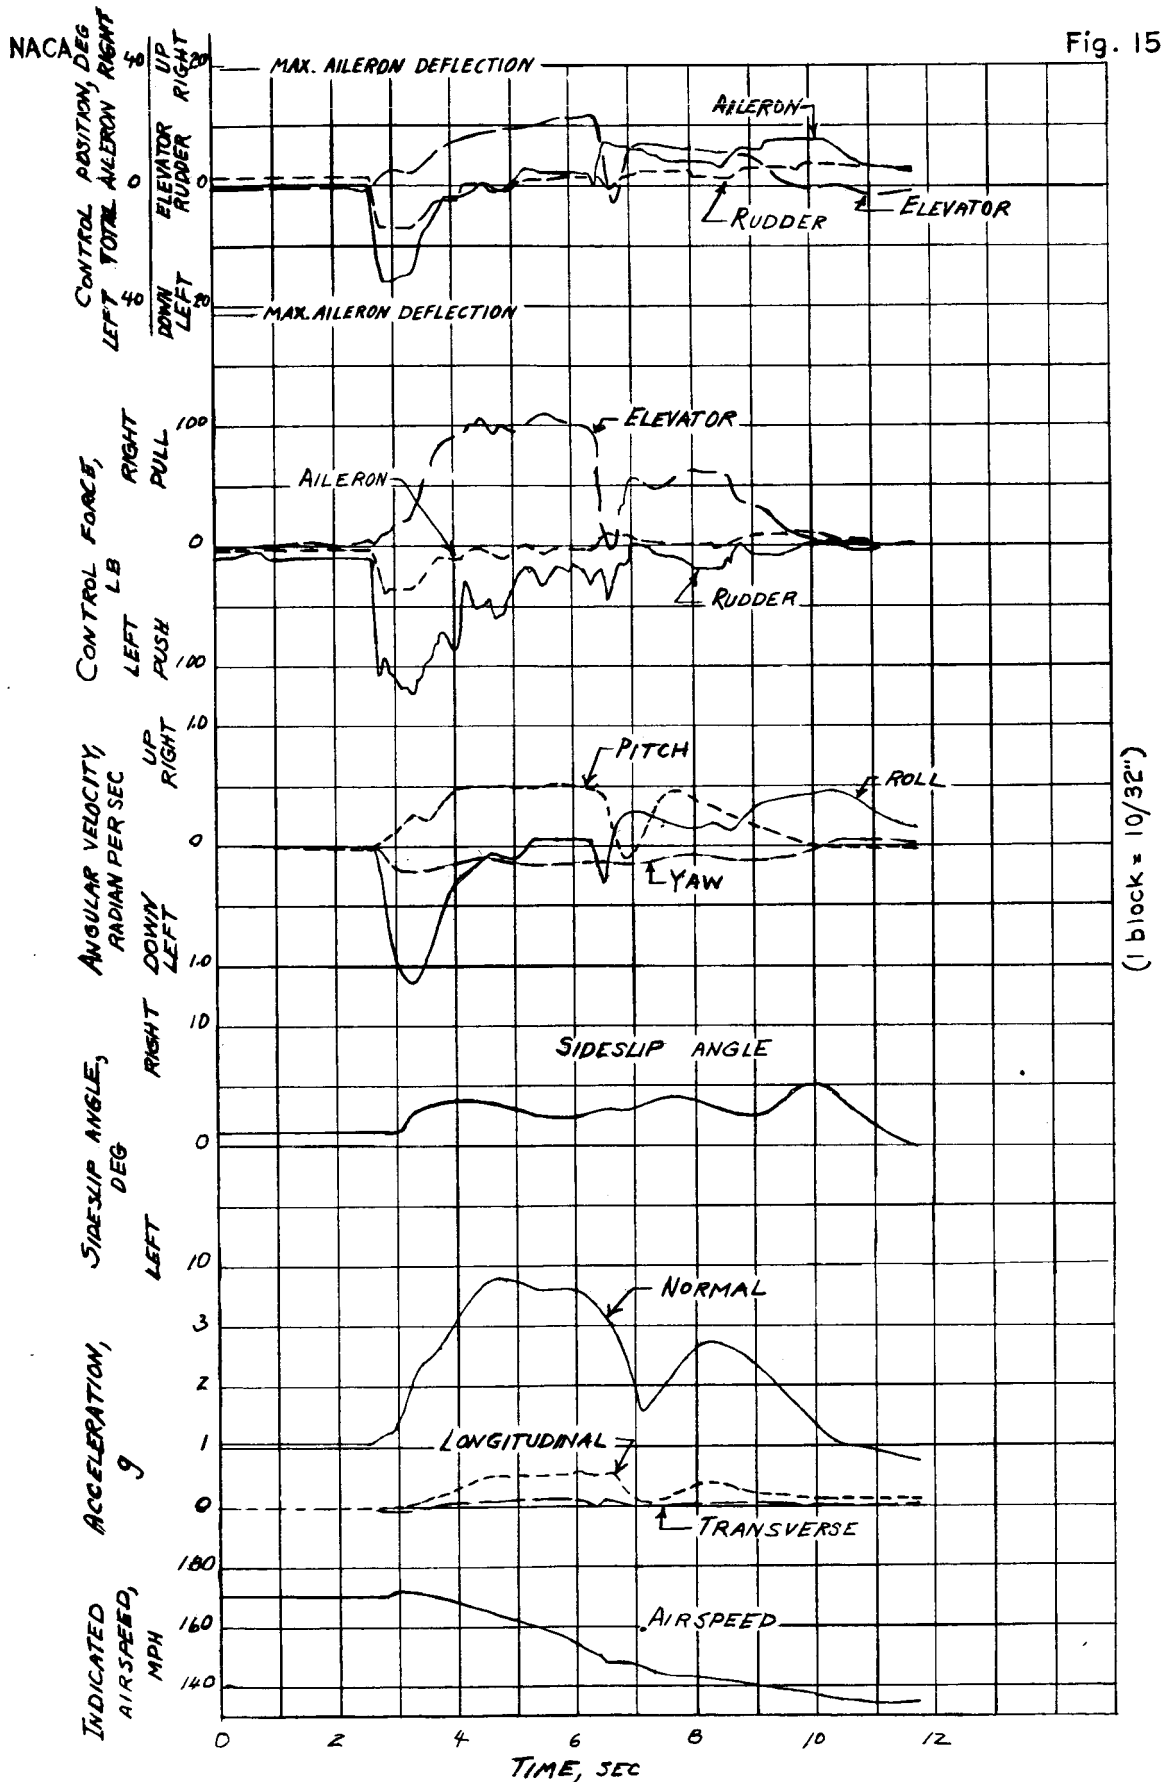
Figure 15. - Time history of a rapid turn to the left started at 171 miles per hour, in which a stall occurred. Brewster XSBA-1 airplane; flaps up, gear up, 18 inches Hg manifold pressure, 1800 rpm.

(3) Figure 15 shows a time history of a turn in which the stick was pulled back until a stall occurred; an elevator deflection of 12° from the trim position was required to reach the maximum lift coefficient. This deflection corresponds to a stick movement of 4.6 inches, which satisfies the requirements of reference 1.

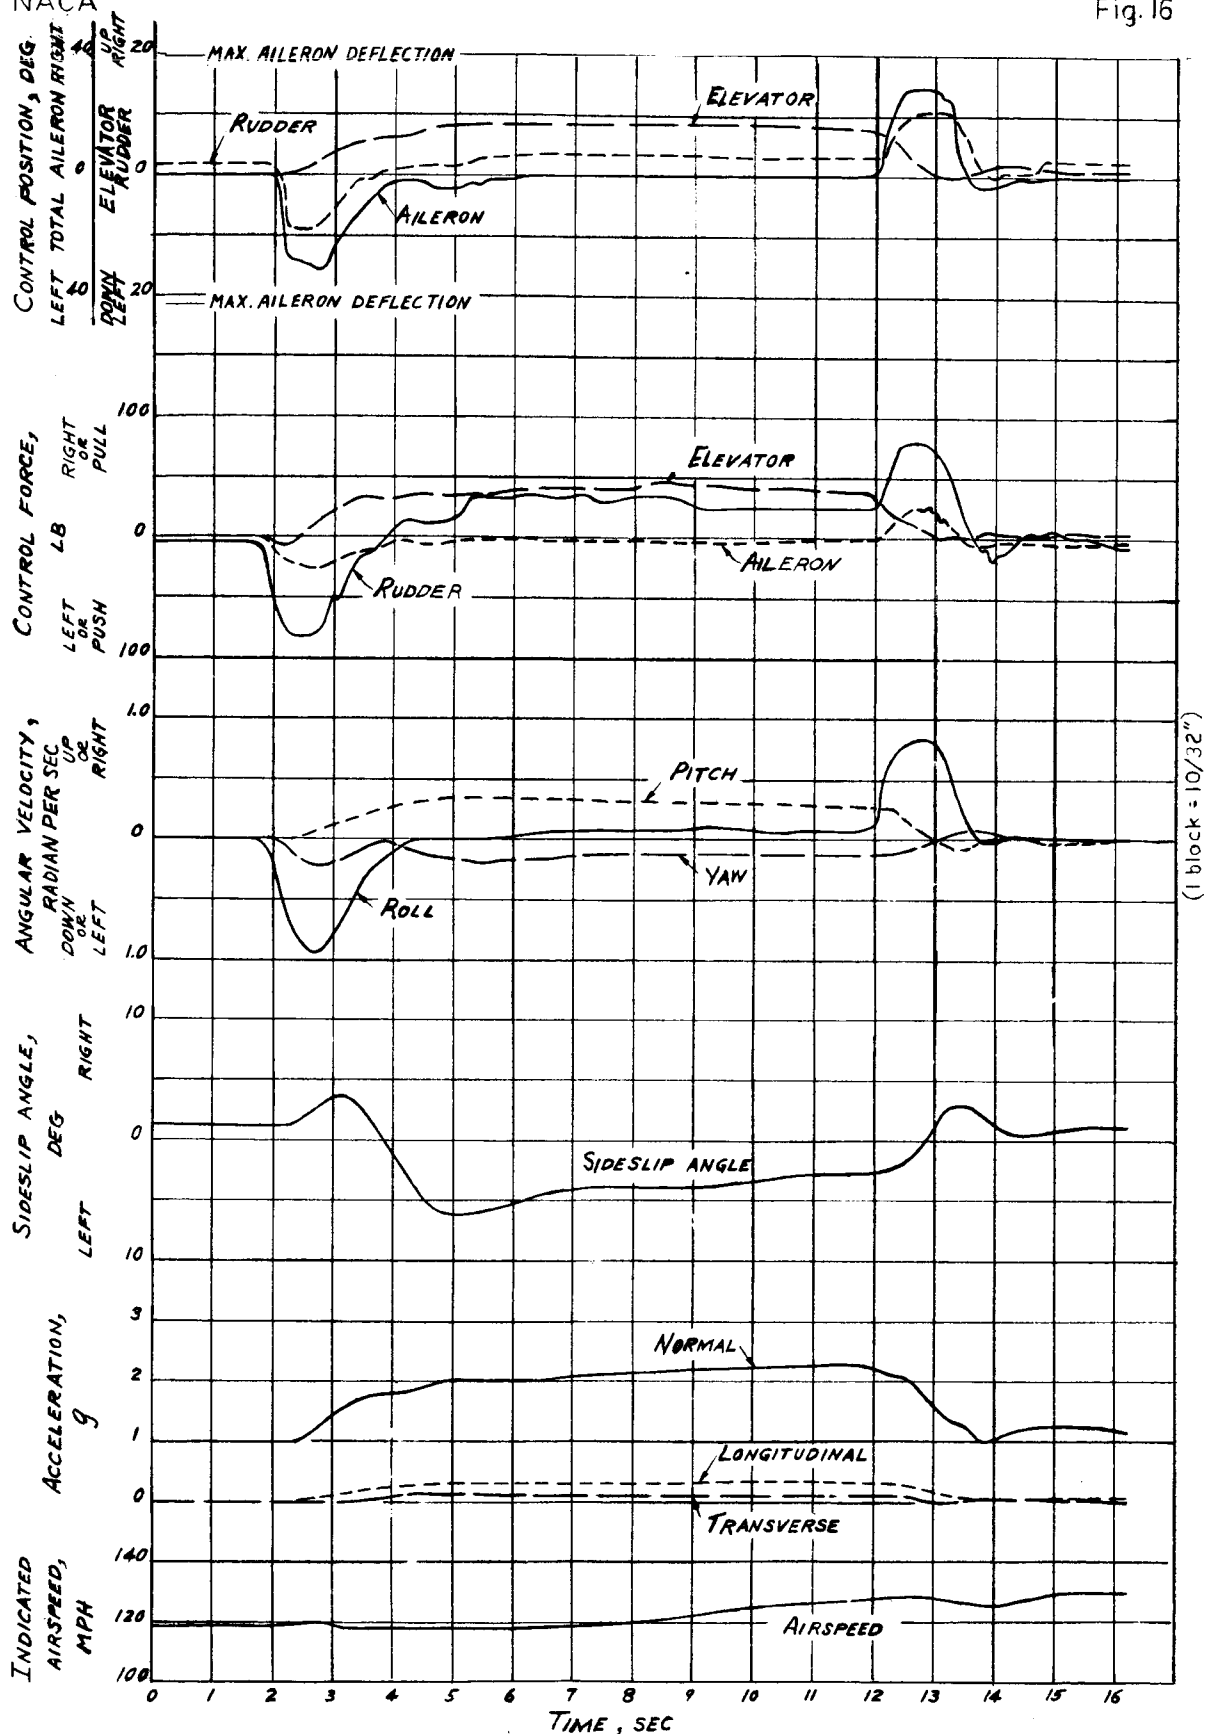
Fig. 16

Figure 16. - Time history of a rapid 180° turn to the left started at 119 miles per hour. Brewster XSBA-1 airplane; flaps up, gear up, 18 inches Hg manifold pressure, 1800 rpm.
